TECHNICAL CONDITION ASSESSMENT

North Dakota Veterans Home Lisbon, North Dakota

December 2006

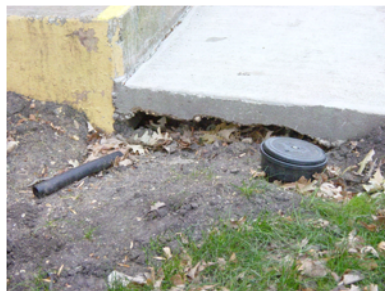
Erosion under sidewalk at north end of building.

Site drainage on the surface, and runs generally to the north and east. There are numerous swales and other surface drainage elements. Holes have been provided in curbs and planter borders to allow for drainage. Exposed PVC pipe is used to drain storm water adjacent to the Gazebo. On the north end of the original portion, and on the west side of the 1980 addition, the soil adjacent to the building has settled, creating areas where water will pond adjacent to the structure. Staff reported that storm water used to infiltrate the Laundry. Additional fill has been added, and more is necessary. On the north side of the staff parking lot on the east side of the building, there is some minor erosion where the drainage passes under a chain link fence. There is also some minor erosion at the east end of the 1990 episode adjacent to where the rain water leader discharges, and also under the sidewalk at the north end of the original portion.

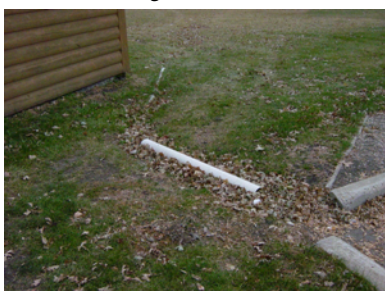
Exposed PVC storm drainage piping near Gazebo.

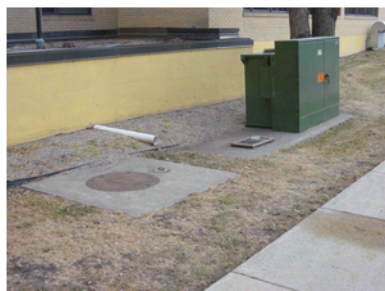
Settlement adjacent to west side of laundry allows ponding.

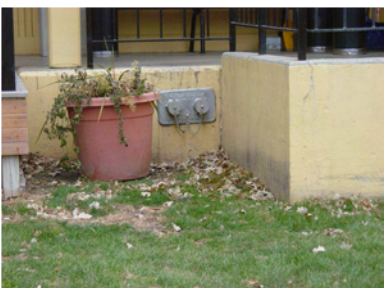
Limited access to fire department siamese connection.

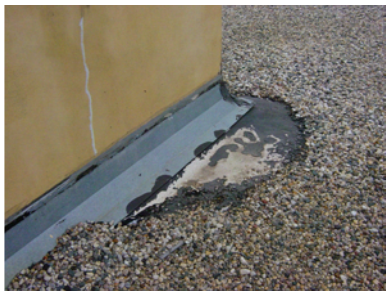
Aggregate surfacing shifting.

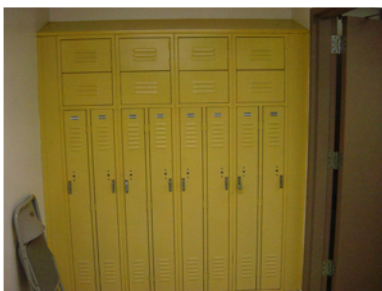
Narrow staff lockers.

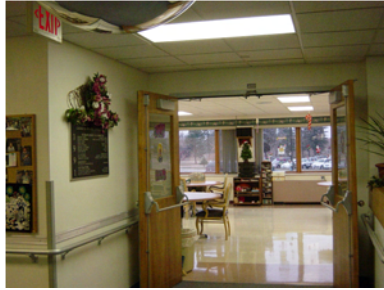
Doors to Activity Room in 1990 episode. Note direction of swing and exit sign.

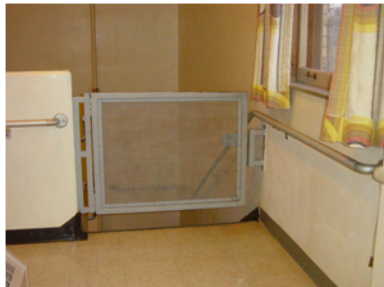
Gate obstructing means of egress at stairs adjacent to Activity Room.

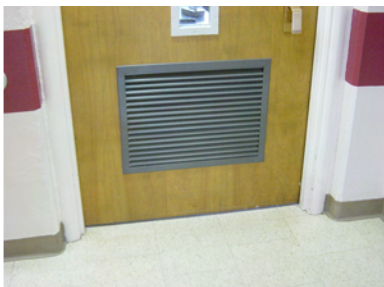
Louver on corridor door.

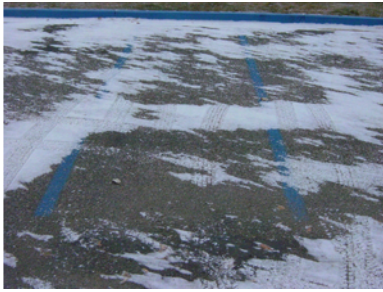
In all the parking areas the striping is either worn off or fading away.

Parking space striping fading.

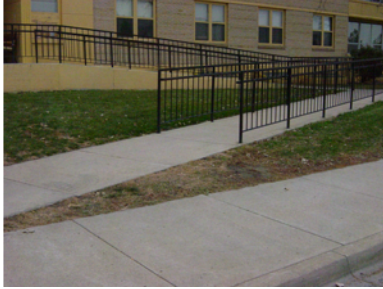
Lack of handrail extensions at ramp.

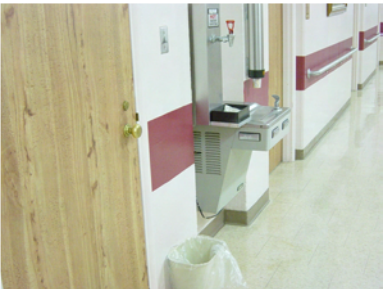
Electric water cooler forms obstacle.

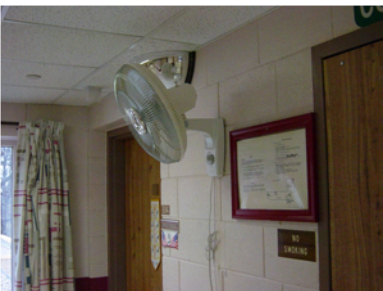
Wall-mounted fan forms obstacle.

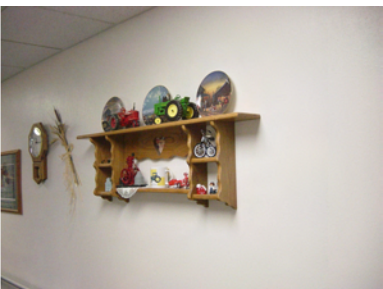
Bric-a-brac shelf form obstacle.

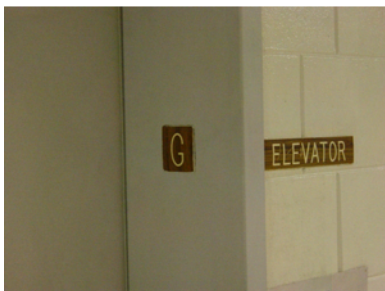
Non-compliant hoistway sign.

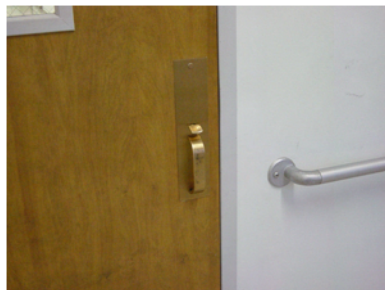
Many doors still have knobs and a few, including doors at stairs in the original portion of the facility, have thumbpiece latchsets.

Thumbpiece latch on door.

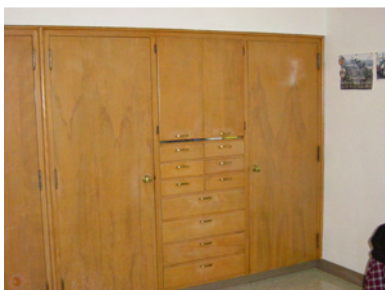
Storage facilities within resident rooms are not accessible. Clothes rods in the 1980 episode are 70 inches above the floor.

Resident storage unit in original portion.

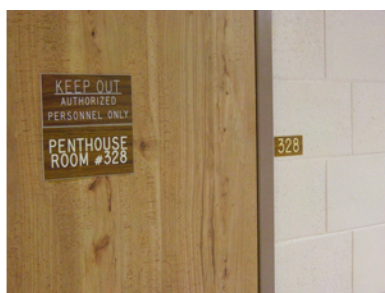
Non-compliant room and door sign.

In the original portion of the building and the 1980 addition, room signs are non-compliant. Directional signs throughout the facility are non-compliant.

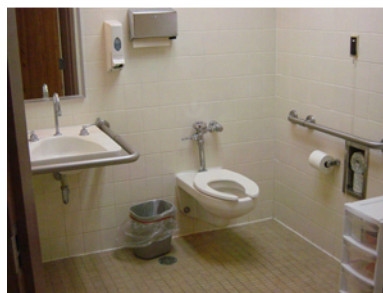
Resident toilet rooms in the original portion of the building are totally inaccessible, as are the resident toilet rooms in the NE corner of the 1980 addition. Other resident toilet rooms in the 1980 episode do not provide the required clearance at the water closet and there is no grab bar behind the water closet. The resident toilet rooms in the 1990 addition appear to conform to ADA requirements.

Resident toilet room in 1978 addition; note lack of rear grab bar.

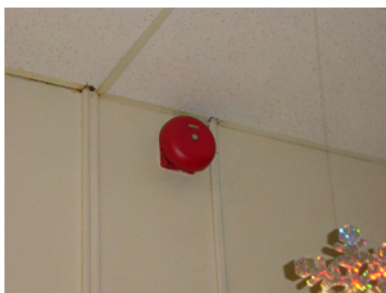
There are no strobe-type fire alarm horns in many group spaces in the original portion of the building including toilet rooms, TV rooms, the libraries, the Museum, the Activity Room, and the smoking room. There are no strobe-type horns in the smoking room of the 1978 addition, or in the Physical Therapy Room in the 1990 episode.

Alarm bell in Activity Room in original portion.

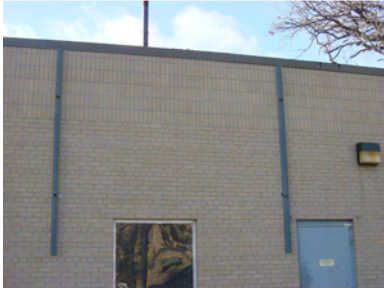
Angles used to secure tie rods through building.

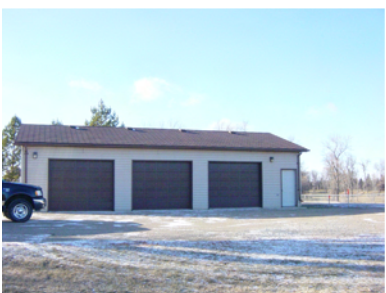
Three-stall garage.

Both the weatherstripping and the finish on the overhead doors are deteriorating.

The wood entrance door is deteriorating due to paint failure and age of the door.

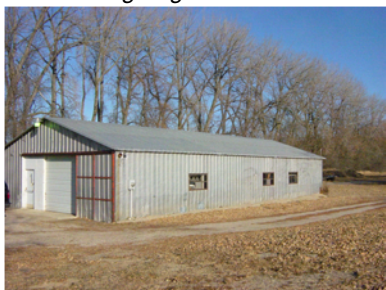
Metal storage building.

The metal panels are dented, torn and otherwise damaged, with numerous repair patches. The galvanized finish is deteriorating allowing the base metal to rust.

The sliding door on the west side was removed and replaced with a coiling garage door, an adjacent walk-door and painted plywood. The paint is deteriorating. The sliding door on the east side is difficult to operate.
